## Building a new shared storage facility for 16 museums and archives

Lise Ræder Knudsen\* and Michael Højlund Rasmussen

Vejle County Cultural Heritage Centre

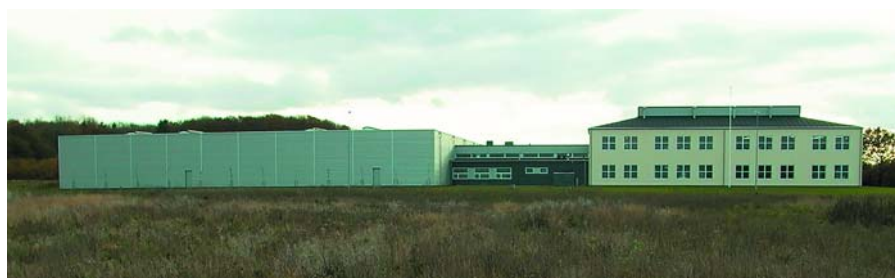
Figure 1. Vejle County Cultural Heritage Centre. Left, shared store for 16 museums and archives; middle, loading area, freezing unit for disinfection and staff facilities; right: conservation laboratory

As the regional conservation centre had to move at the same time, it was decided to build a combined conservation centre and storage facility – Vejle County Cultural Heritage Centre – on a central site near the motorway. The conservators would then be close to the collections and could monitor the climate and supervise the museums.

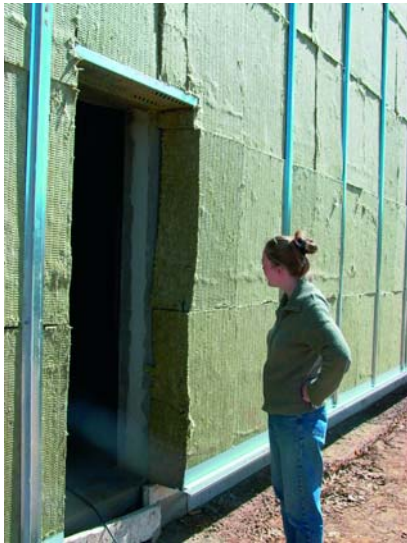
Figure 2. Erecting the walls in June 2003. The climate is stabilized by solid walls of 240 mm open-pored concrete. Note the 250 mm isolation on the outside of the wall

A solid concrete building with exterior isolation and no isolation in the floor was built on the principles of passive climate control. The walls are made of 240 mm concrete, which offers a climate buffering effect and good security, 250 mm outside isolation and a metal sheet protection (Christoffersen 1995). The building consists of two halls each of 1700 m<sup>2</sup> with a rafter width of 24 m and no columns. This width provides best economic value. We had to enter into a compromise with the roof: its slope is only 4 per cent whereas we would have preferred a pitched roof, but the cost would have been unfeasible. Rainwater drains run through two of the storage rooms, which means a risk of water damage. The rafters are made of TT concrete; metal sheet material connects them and an isolation layer of 300 mm under a double-felted roof that surmounts the house. Inside, the walls are painted with a concrete-based white paint of very low PAM value, and the floors with a water-based epoxy paint.

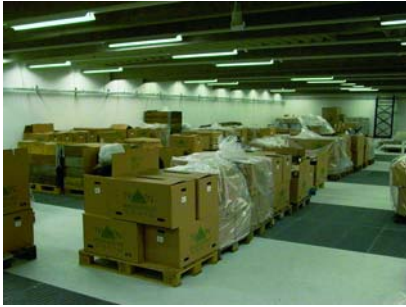
Figure 4. Textile boxes after cleaning and disinfection by freezing ready to be moved to their shelves

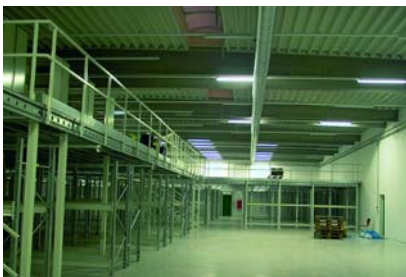
Figure 5. Storage system in one of the main halls of the store

A mezzanine construction placed upon pallet shelves was the most economic choice. The mezzanine floor over the aisles consists of industrial gratings. Over the pallet shelves, however, concrete-based, chemically inert chipboard was placed to prevent dirt from falling on the objects on the pallets. The industrial gratings offer good ventilation, better fire alarm warning with fewer detectors, and they reduce the costs to only 80 per cent of those of a concrete mezzanine. Furthermore, one gets the pallet shelves 'for free' because they carry the mezzanine.

The mezzanine is 2.7 m high, which means that a simple pallet-lifting device can place the objects on the mezzanine.

The fire authorities only allowed a mezzanine of three-quarters the size of the floor space. Therefore the total area of each hall was divided into a main path and an open floor space for large objects placed on pallets. This area was one-quarter of the floor space area. On the remaining three-quarters area the mezzanine was raised. Pallet shelves were installed under the mezzanine for medium-sized objects, and the mezzanine was reserved for small objects.
